July 3, 2019

**RE:** Amendment to the May 15, 2019 Fenceline Benzene Monitoring Corrective Action Plan for the Artesia Refinery

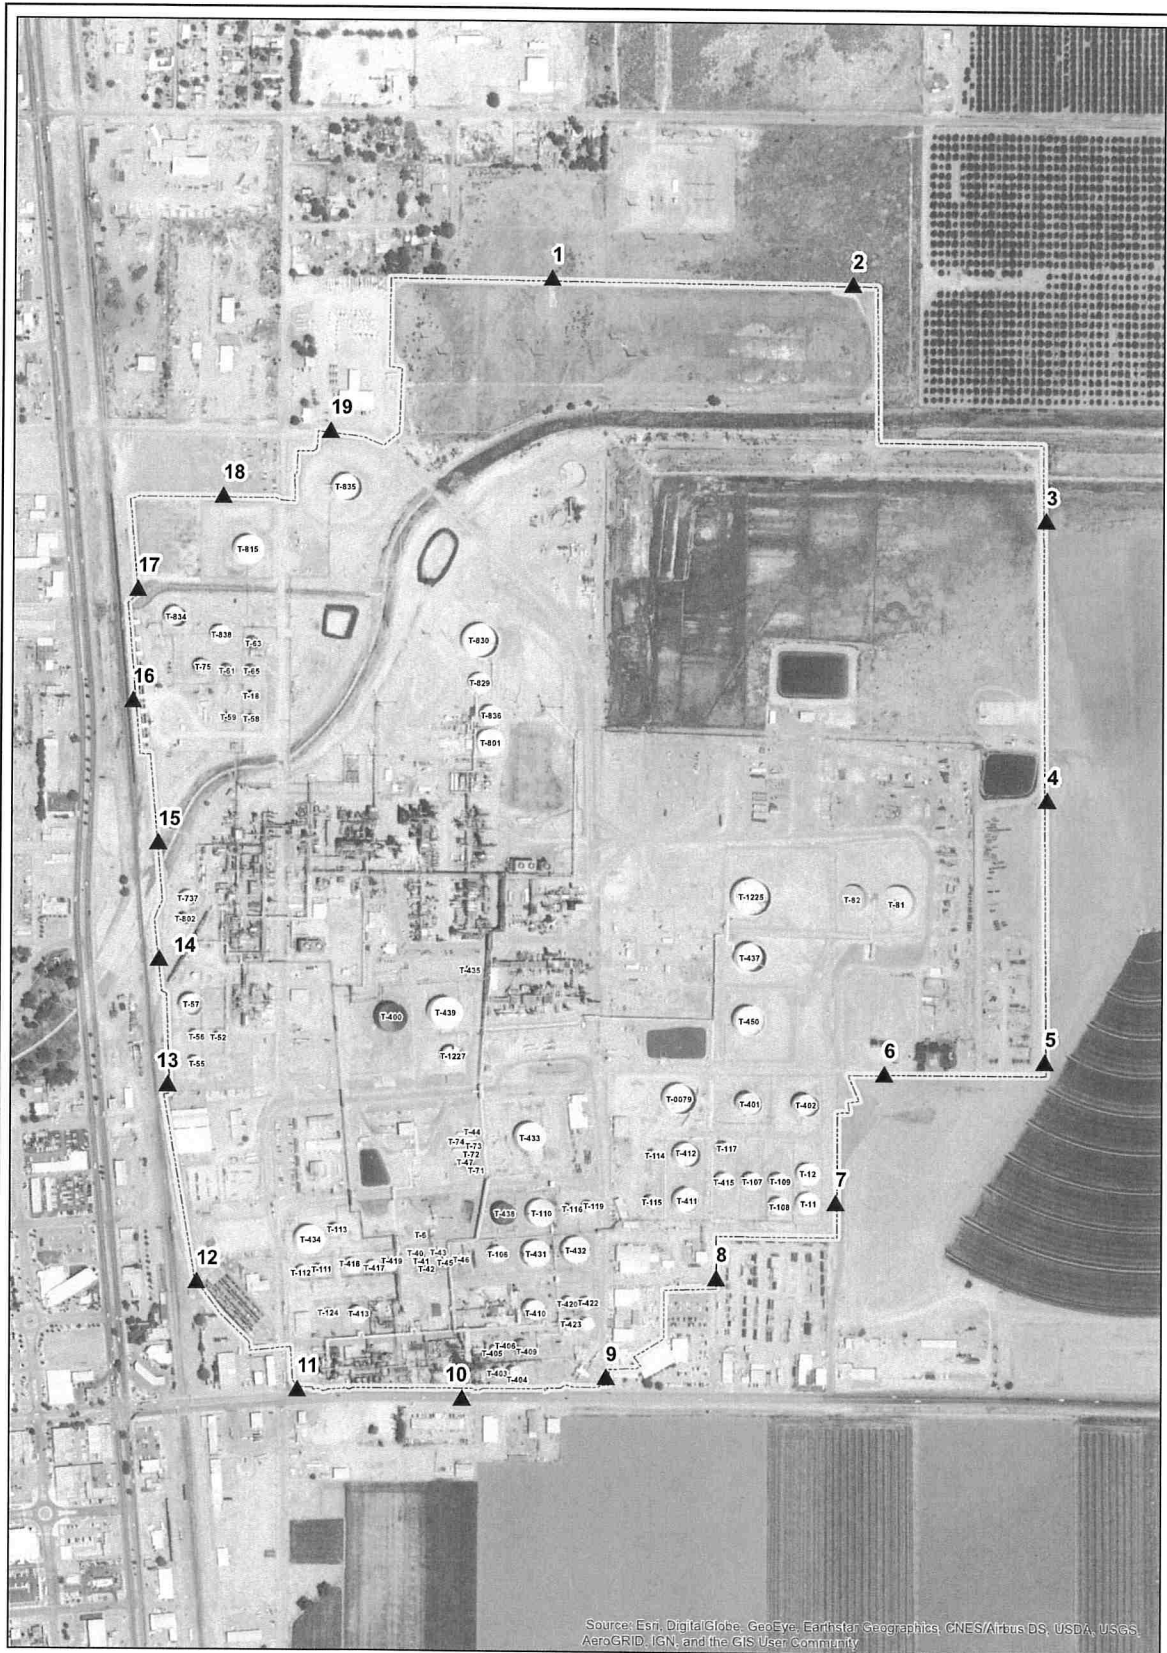
FIGURE 1

- 2/26 to 3/12: sample event  $\Delta c = 10.6 \mu\text{g}/\text{m}^3$   
Monitoring locations 13, 14, and 15 were above  $9 \mu\text{g}/\text{m}^3$
- 3/12 to 3/26: sample event  $\Delta c = 12.5 \mu\text{g}/\text{m}^3$   
Monitoring locations 7, 8, 9, and 10 were above  $9 \mu\text{g}/\text{m}^3$

- 3/26 to 4/9: sample event  $\Delta c = 54.2 \mu\text{g}/\text{m}^3$   
Monitoring locations 13, 14, and 15 were above  $9 \mu\text{g}/\text{m}^3$
- 4/9 to 4/23: sample event  $\Delta c = 66.2 \mu\text{g}/\text{m}^3$   
Monitoring locations 7, 10, 14, 15, and 16 were above  $9 \mu\text{g}/\text{m}^3$

- 4/23 to 5/7: sample event  $\Delta c = 203.5 \mu\text{g}/\text{m}^3$   
Monitoring locations 6, 13, 14, 15, 16, and 17 were above  $9 \mu\text{g}/\text{m}^3$

- 5/7 to 5/21: sample event  $\Delta c = 99.0 \mu\text{g}/\text{m}^3$   
Monitoring locations 14, 15, and 16 were above  $9 \mu\text{g}/\text{m}^3$
- 5/21 to 6/4: sample event  $\Delta c = 28.5 \mu\text{g}/\text{m}^3$   
Monitoring locations 14 and 15 were above  $9 \mu\text{g}/\text{m}^3$
